**PHASE II ENVIRONMENTAL SITE ASSESSMENT
REPORT**

**for
OHIO BLENDERS PROPERTY**

**NORTHWEST TRIANGLE INITIATIVE
City of York
York County, Pennsylvania**

September 2009

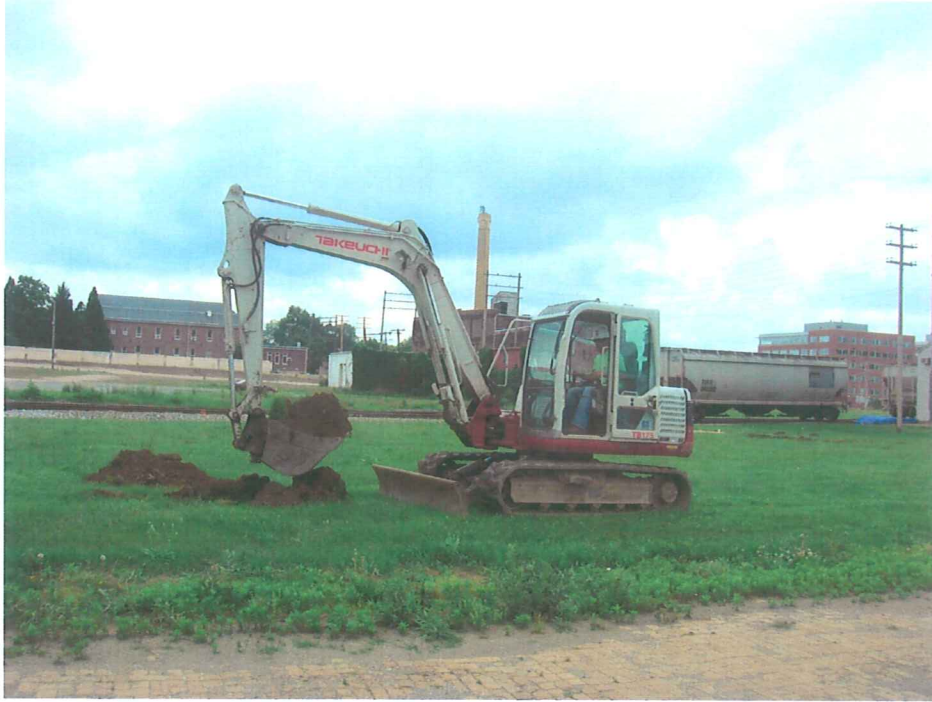
A mini-excavator was used on June 12, 2009 to investigate potential UST locations that were identified in the GTS Technologies interim site characterization report. No USTs were discovered during the test pit activities, and it appears that all USTs have been previously removed from the site.

Using Mini-Excavator to check for underground storage tanks.

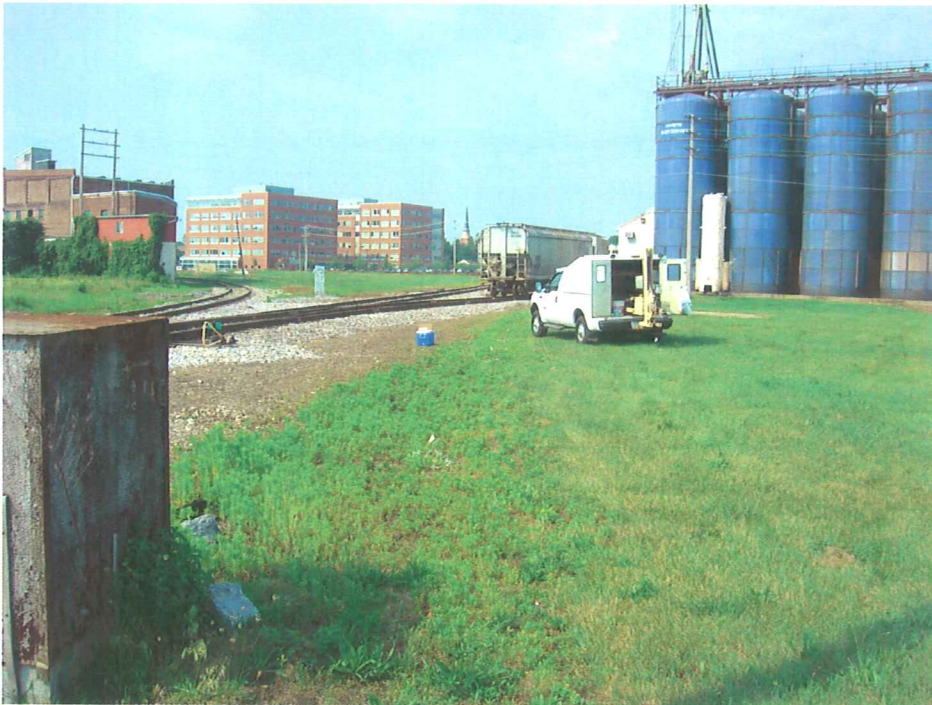
ARM collected 165 shallow and deep subsurface soil samples across the Ohio Blenders property using Geoprobe direct-push equipment. These samples were collected over the course of a series of investigations, from June through August 2009, with the primary goals of characterizing the nature of contamination in the soils at the site, and delineating the vertical and horizontal extent of contamination at the site. The sample locations are shown on the attached Figures 2, 3, and 4, and the laboratory results are summarized on Table 1.

Soil sampling with a geoprobe.

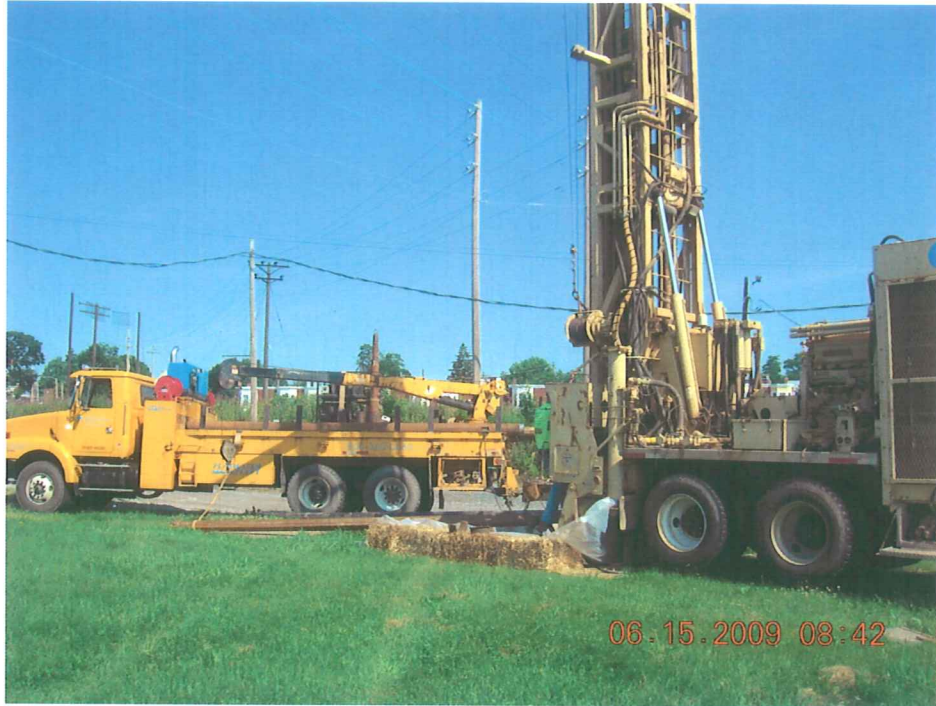
Installing MW-5S.

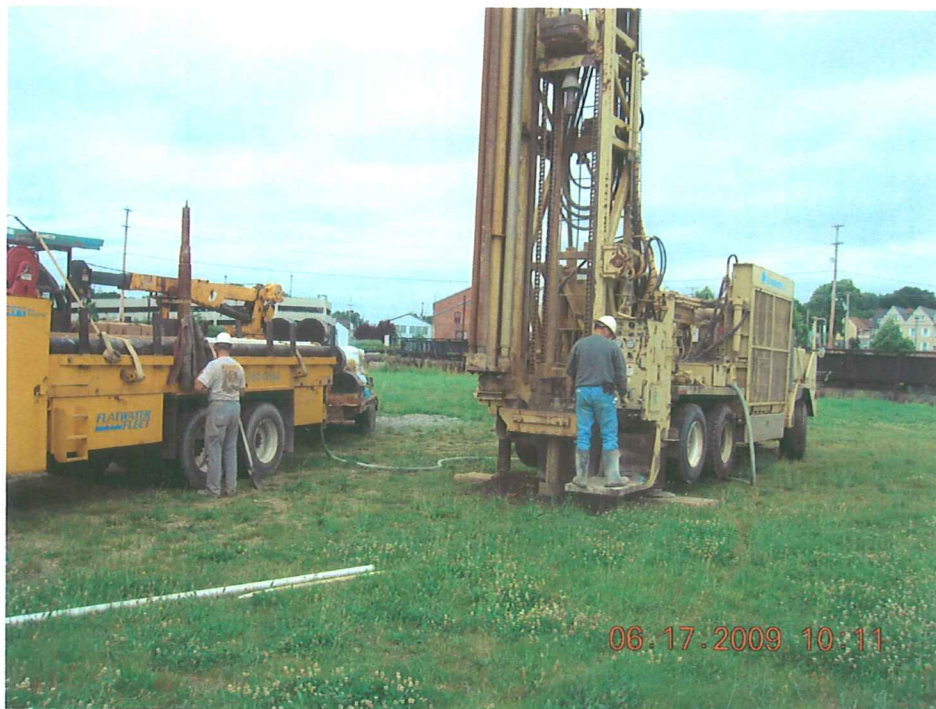
Installing MW-3S.
